## An Apartment Inventory Road, Inventory Town, Inventoryshire, England, TN8 1NV

**TENANCY START DATE**  
06/03/2021

**PROPERTY VISIT DATE**  
05/03/2021

**PREPARED ON BEHALF OF**  
Looksy Inventories  
**Telephone:** 07521  
052360

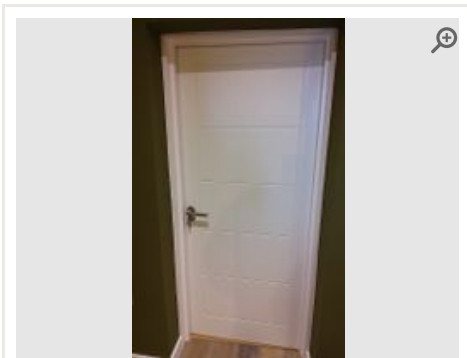
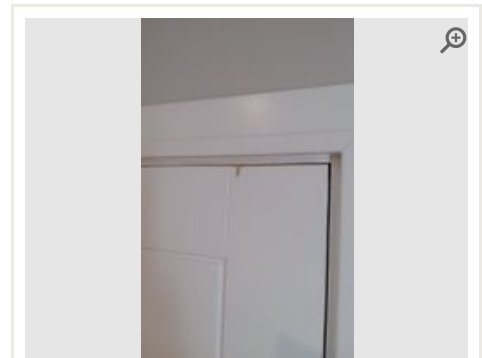
### Front Door

Item	Description	Condition	Cleanliness	Photos
<b>General Overview</b> 2.1	Clean & Tidy	● New Item	● Good	📷 3 photos
<b>Front Door</b> 2.2	Wood (no glazing). Brushed chrome handle. Yale lock. Chrome/rubber door stop. White Small mark to centre external. Chips to top internal.	● New Item	● Good	📷 3 photos
<b>Door Frame &amp; Skirting</b> 2.3	Painted white. 2 x holes to frame. Some minor marks and light dust to skirting.	● New Item	● Fair	📷 3 photos
<b>Ceiling</b> 2.4	Plastered/Painted white	● New Item	● Good	📷 1 photo
<b>Light Fittings</b> 2.5	Ceiling. LED downlighter. 6 fixings in total. All bulbs working	● New Item	● Good	📷 1 photo
<b>Smoke Alarm</b> 2.6	Ceiling mounted. Test button/function working. Wired. Ei Electronics. Tenant note: Test periodically. Tenant note: Do not obstruct the unit	● New Item	● Good	📷 1 photo
<b>Walls</b> 2.7	Plastered & painted. Grey Some very faint minor marks.	● New Item	● Good	📷 3 photos

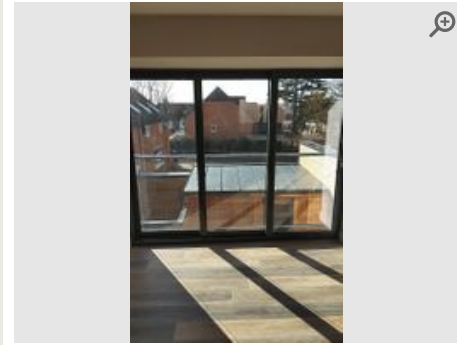
Provided by	<b>Inspector</b>
Captured (via App):	<b>05/03/2021 9:30 AM</b>
Added	<b>05/03/2021</b>
Reference	<b>6.10.3</b>

<b>Floor</b> 6.9	Laminate wood effect	● New Item	● Good	📷 3 photos
<b>Patio Doors</b> 6.10	Aluminium double glazed. Chrome handle 2 x sliding doors and one fixed panel. Yale type lock. Some minor scratches to frame. Stainless bar and 3 x glass panels to exterior - require a clean.	● New Item	● Fair	📷 5 photos
