## An Apartment Inventory Road, Inventory Town, Inventoryshire, England, TN8 1NV

**TENANCY START DATE**  
06/03/2021

**PROPERTY VISIT DATE**  
05/03/2021

**PREPARED ON BEHALF OF**  
Looksy Inventories  
**Telephone:** 07521  
052360

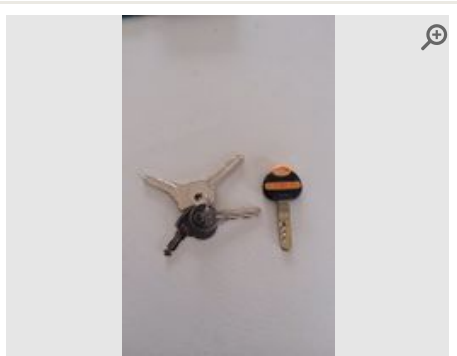
Provided by	<b>Inspector</b>
Captured (via App):	<b>05/03/2021 10:43 AM</b>
Added	<b>05/03/2021</b>
Reference	<b>1.1.1</b>

1 keys				
Item	Description	Condition	Cleanliness	Photos
General Overview 1.1	2 x front door, 1 x communal door, 1 x sliding door key and 1 x post box key.	<span style="color: green;">●</span> New Item	<span style="color: green;">●</span> Good

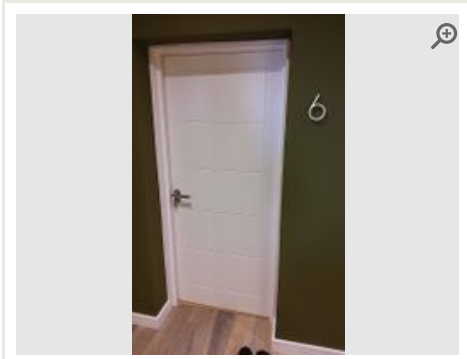
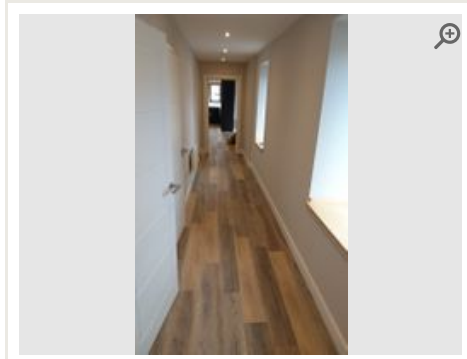
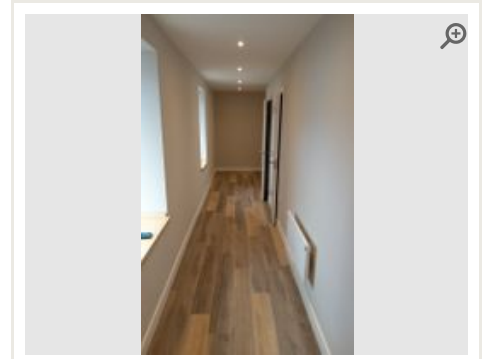
### General Overview

Item	Description	Condition	Cleanliness	Photos
<b>General Overview</b> 2.1	Clean & Tidy	● New Item	● Good	📷 3 photos
<b>Front Door</b> 2.2	Wood (no glazing). Brushed chrome handle. Yale lock. Chrome/rubber door stop. White Small mark to centre external. Chips to top internal.	● New Item	● Good	📷 3 photos
<b>Door Frame &amp; Skirting</b> 2.3	Painted white. 2 x holes to frame. Some minor marks and light dust to skirting.	● New Item	● Fair	📷 3 photos
<b>Ceiling</b> 2.4	Plastered/Painted white	● New Item	● Good	📷 1 photo
<b>Light Fittings</b> 2.5	Ceiling. LED downlighter. 6 fixings in total. All bulbs working	● New Item	● Good	📷 1 photo
<b>Smoke Alarm</b> 2.6	Ceiling mounted. Test button/function working. Wired. Ei Electronics. Tenant note: Test periodically. Tenant note: Do not obstruct the unit	● New Item	● Good	📷 1 photo
<b>Walls</b> 2.7	Plastered & painted. Grey Some very faint minor marks.	● New Item	● Good	📷 3 photos

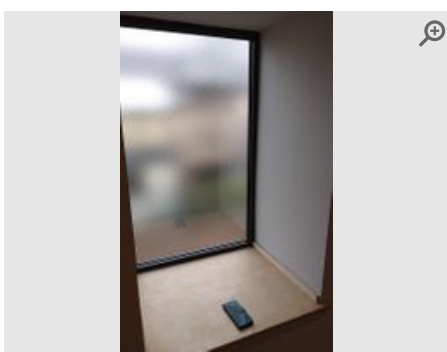
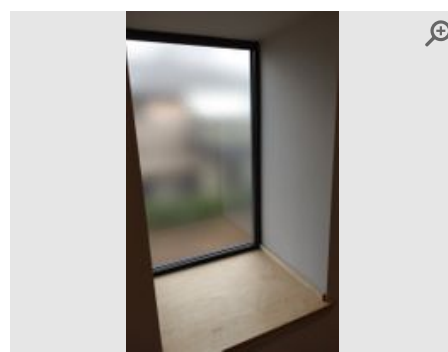
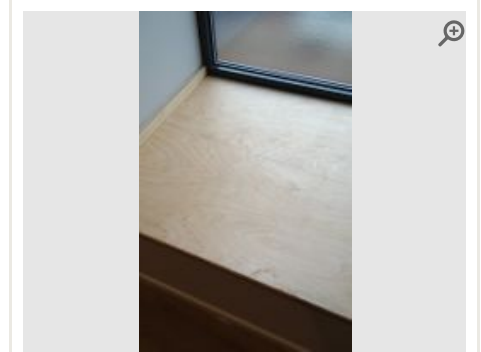
### Windows and Sills

<b>Windows and Sills</b> 2.8	Standard window. 2 in total. Wooden sills	● New Item	● Good	📷 3 photos
<b>Radiator</b> 2.9	Electric wall-mounted. 1 in total	● New Item	● Good	📷 1 photo
<b>Sockets &amp; Switches</b> 2.10	All sockets/switches plastic. 6 in total	● New Item	● Good	📷 4 photos
<b>Floor</b> 2.11	Laminate wood effect Some minor debris.	● New Item	● Fair	📷 3 photos
<b>Service Cupboard</b> 2.12	Door - wooden painted white with brushed chrome handle and chrome coat rack to interior - some minor marks and faint squiggle mark to external. Contents as pictured. Some marks to walls.	● New Item	● Good	📷 8 photos
<b>Telephone Entry System</b> 2.13	Touchscreen. Fascia intact	● New Item	● Good	📷 1 photo

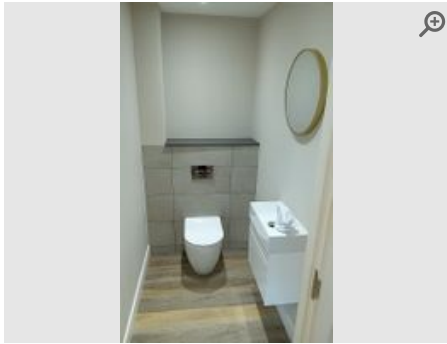
**General Overview**

Item	Description	Condition	Cleanliness	Photos
<b>General Overview</b> 3.1	Clean & Tidy	● New Item	● Good	📷 1 photo
<b>Door (Internal)</b> 3.2	Wood panelled. Brushed chrome handle. Integrated privacy lock. White	● New Item	● Good	📷 3 photos
<b>Door Frame &amp; Skirting</b> 3.3	Painted white. Light dust to skirting.	● New Item	● Fair	📷 2 photos
<b>Ceiling</b> 3.4	Plastered/Painted white Duct present.	● New Item	● Good	📷 2 photos
<b>Light Fittings</b> 3.5	Ceiling. LED downlighter. 2 fixings in total. All bulbs working	● New Item	● Good	📷 1 photo
<b>Walls</b> 3.6	Plastered & painted. Grey Small mark above sink.	● New Item	● Good	📷 3 photos
<b>Sockets &amp; Switches</b> 3.7	All sockets/switches plastic. 1 in total	● New Item	● Good	📷 1 photo
<b>Floor</b> 3.8	Laminate wood effect	● New Item	● Good	📷 1 photo
<b>Sink/Basin</b> 3.9	Wall-mounted porcelain. Mixer tap. Chrome taps. Mechanised plug White gloss vanity unit below with instruction manuals inside.	● New Item	● Good	📷 3 photos

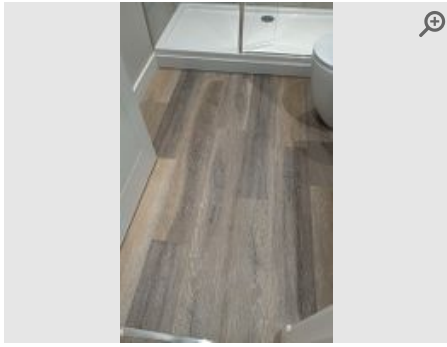
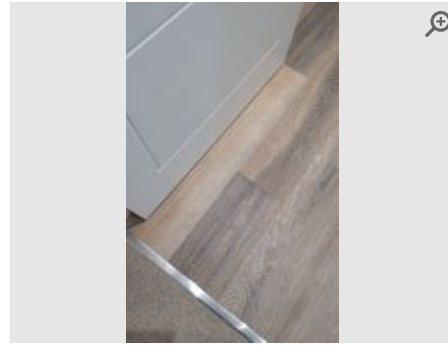
## Floor

Item	Description	Condition	Cleanliness	Photos
<b>General Overview</b> 5.1	Clean & Tidy	● New Item	● Good	📷 2 photos
<b>Door (Internal)</b> 5.2	Wood flat-panel. Brushed chrome handle. Chrome/rubber door stop. White	● New Item	● Good	📷 3 photos
<b>Door Frame &amp; Skirting</b> 5.3	Painted white. Light dust to skirting.	● New Item	● Good	📷 1 photo
<b>Ceiling</b> 5.4	Plastered/Painted white	● New Item	● Good	📷 2 photos
<b>Light Fittings</b> 5.5	Ceiling. LED downlighter. 4 fixings in total. All bulbs working	● New Item	● Good	📷 1 photo
<b>Extractor Fan</b> 5.6	White casing. Free of dust inside	● New Item	● Good	📷 1 photo
<b>Walls</b> 5.7	Plastered & painted. Tiled (around wet areas). Grey Shelf above basin and toilet in dark grey acrylic.	● New Item	● Good	📷 3 photos
<b>Radiator</b> 5.8	Chrome ladder style. 1 in total	● New Item	● Good	📷 1 photo
<b>Floor</b> 5.9	Laminate wood effect Some light debris.	● New Item	● Fair	📷 2 photos

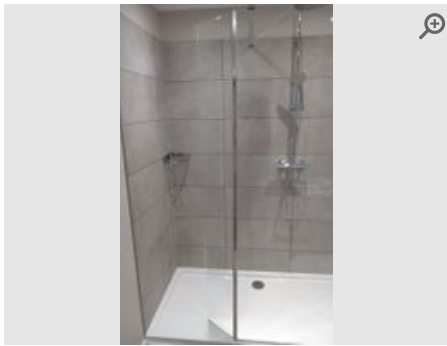
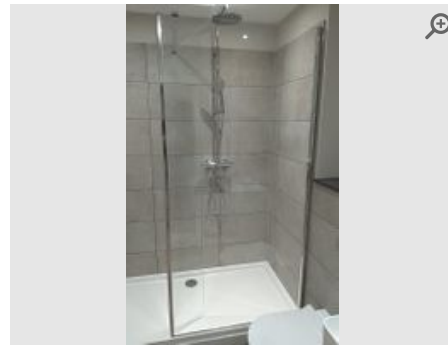
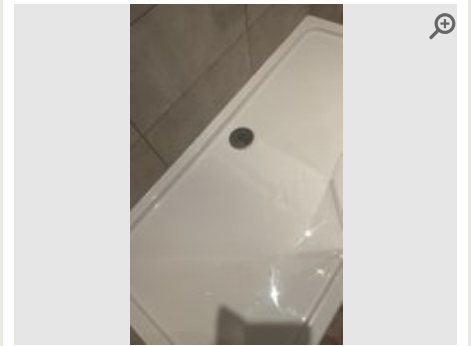
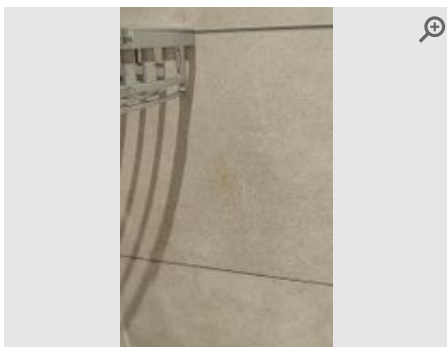
### Shower Cubicle/Screen/Tray

<b>Shower Cubicle/Screen/Tray</b> 5.10	Plastic shower tray. Chrome waste Glazed walk in enclosure with chrome frame. Light brown mark by shelf.	● New Item	● Good	📷 4 photos
<b>Shower</b> 5.11	Shower head & hose. Fixed shower head. Mixer Shower. Chrome	● New Item	● Good	📷 3 photos
<b>Sink/Basin</b> 5.12	Wall-mounted porcelain. Mixer tap. Chrome taps. Mechanised plug Mounted above a 2 drawer gloss vanity unit. Spare shower head in bottom drawer.	● New Item	● Good	📷 4 photos
<b>Toilet</b> 5.13	Porcelain. Plastic/Acrylic seat & lid. Flush button Seat at slight angle.	● New Item	● Good	📷 5 photos
<b>Mirror</b> 5.14	Wall-mounted rectangular Frosted edge sensor lighting.	● New Item	● Good	📷 1 photo
<b>Bathroom Fixings</b> 5.15	Shelving Chrome corner shelf to shower enclosure.	● New Item	● Good	📷 1 photo

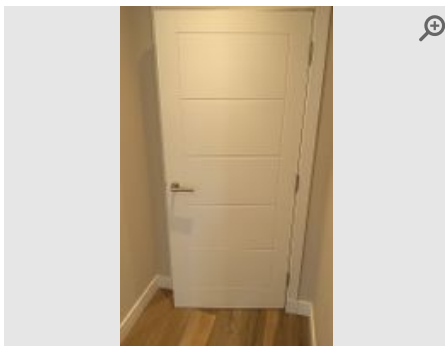
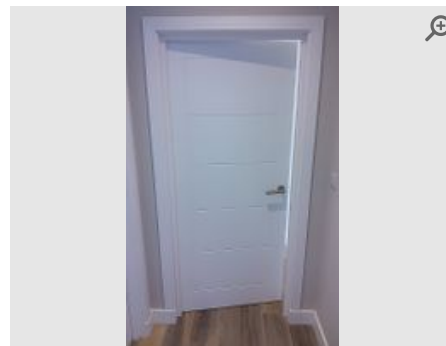
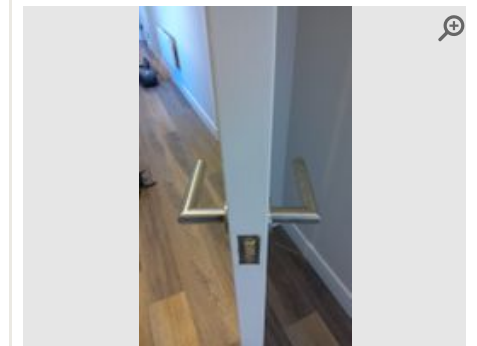
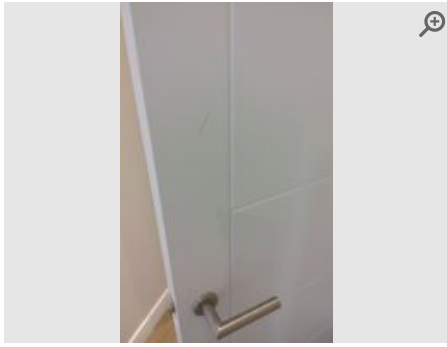
### Door (Internal)

Item	Description	Condition	Cleanliness	Photos
<b>General Overview</b> 6.1	Clean & Tidy	● New Item	● Good	📷 3 photos
<b>Door (Internal)</b> 6.2	Wood flat-panel. Brushed chrome handle. Chrome/rubber door stop. White Scratch to internal above handle.	● New Item	● Good	📷 4 photos
<b>Door Frame &amp; Skirting</b> 6.3	Painted white. Light dust to skirting.	● New Item	● Fair	📷 2 photos
<b>Ceiling</b> 6.4	Plastered/Painted white Duct present.	● New Item	● Good	📷 2 photos
<b>Light Fittings</b> 6.5	Ceiling. LED downlighter. 9 fixings in total. All bulbs working	● New Item	● Good	📷 1 photo
<b>Walls</b> 6.6	Plastered & painted. Grey Some minor marks.	● New Item	● Good	📷 4 photos
<b>Radiator</b> 6.7	Electric wall-mounted. 2 in total. White Residue mark to radiator on right wall.	● New Item	● Good	📷 3 photos
<b>Sockets &amp; Switches</b> 6.8	All sockets/switches plastic. 10 in total Including satellite socket. Some dusty to tops.	● New Item	● Fair	📷 5 photos

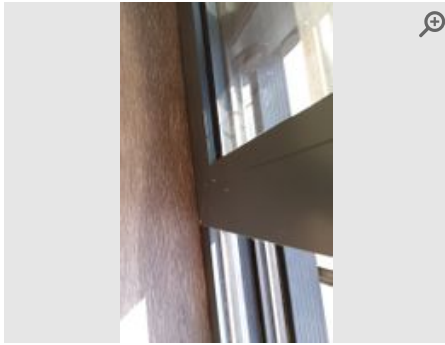
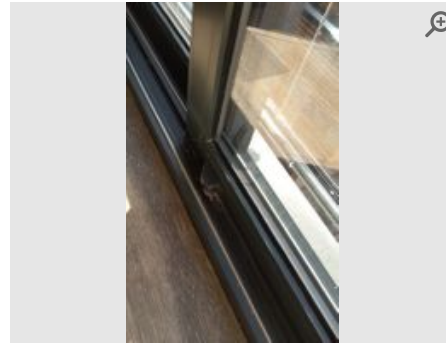
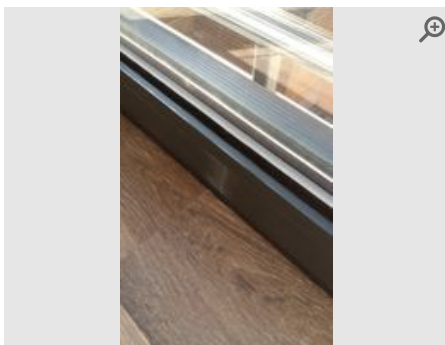
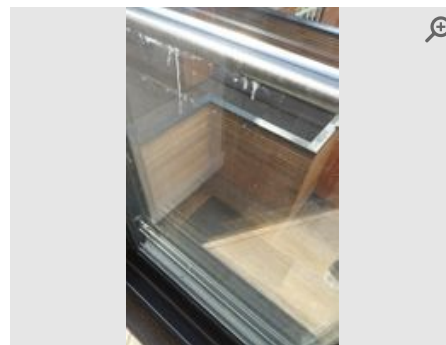
## Patio Doors

<b>Floor</b> 6.9	Laminate wood effect	● New Item	● Good	📷 3 photos
<b>Patio Doors</b> 6.10	Aluminium double glazed. Chrome handle 2 x sliding doors and one fixed panel. Yale type lock. Some minor scratches to frame. Stainless bar and 3 x glass panels to exterior - require a clean.	● New Item	● Fair	📷 5 photos
